clean-exhaust

Two Year Summary

May 2012-March 2014

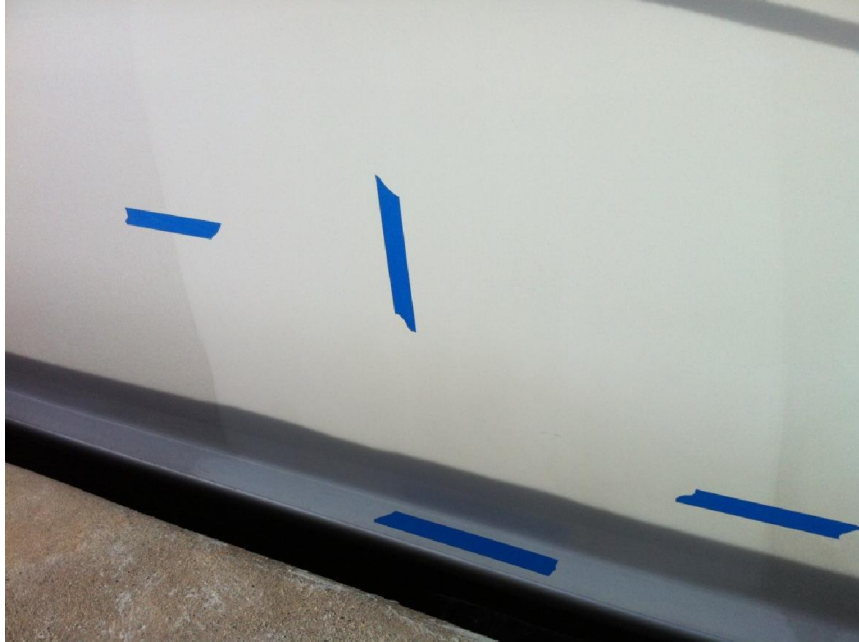
Friday, September 13, 2013, 14:00PM... After readjusting the port generator to 40% of stroke and 40 pulses per minute of *ecoBrew*, a meter square area above the exhaust exit was cleaned and taped.

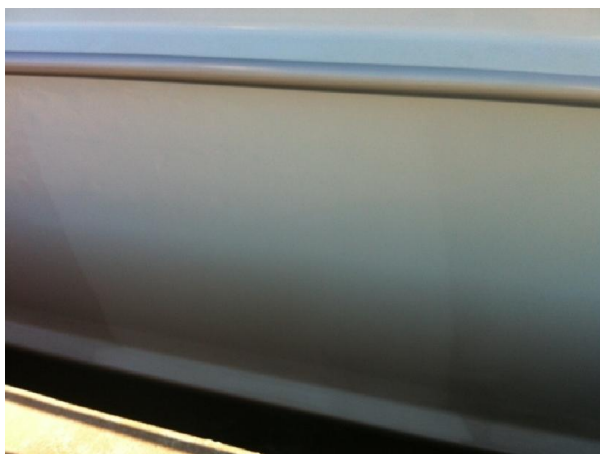
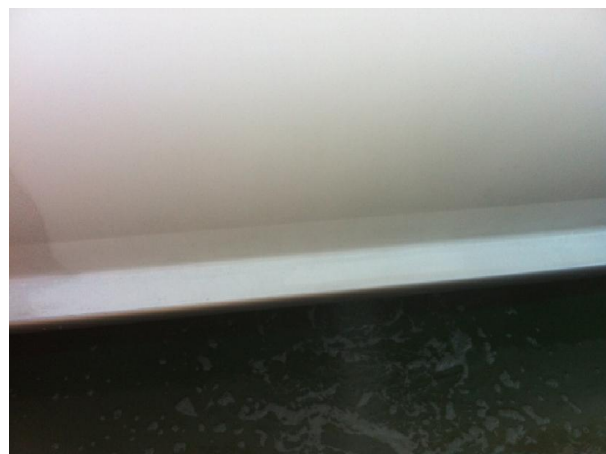
Saturday, September 14, 2013, 10:00 AM (after 20 hours of running time)...

Result - Blue tape was removed on the port side, **particulate was minimal and barely visible** -

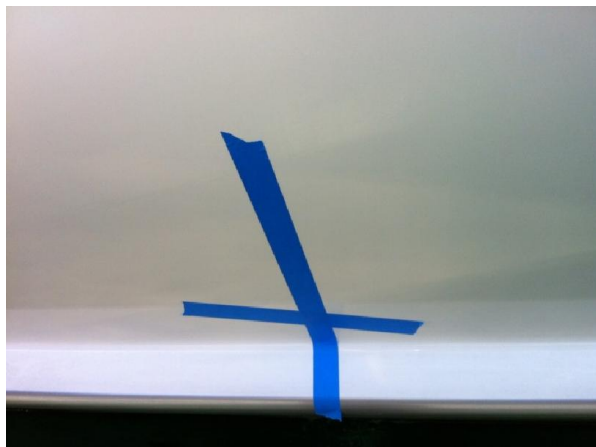
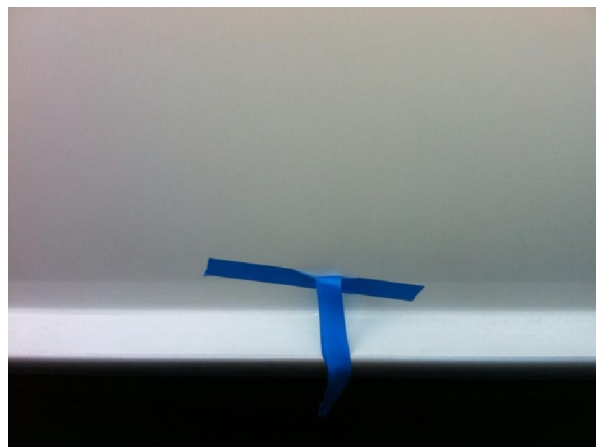
Finger drag across hull produced **no particulate**

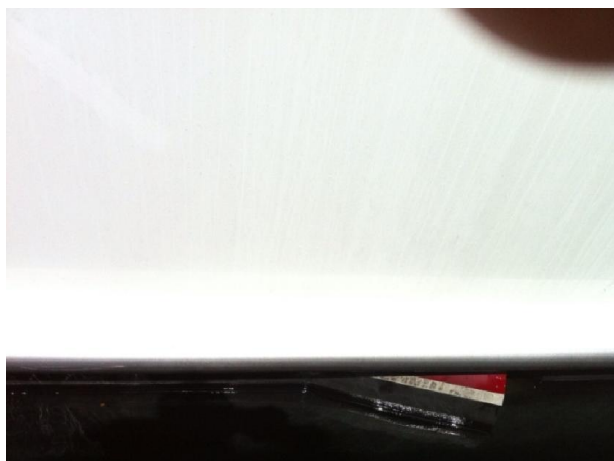
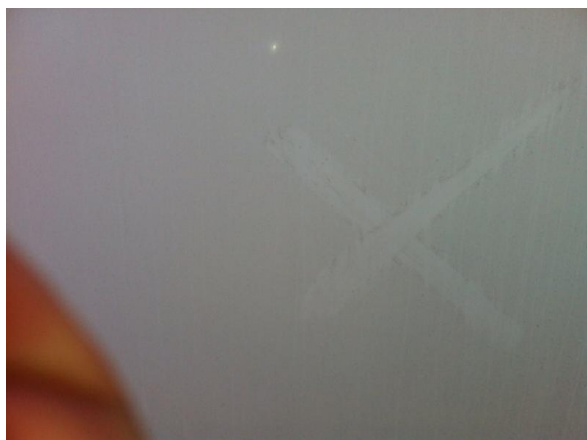
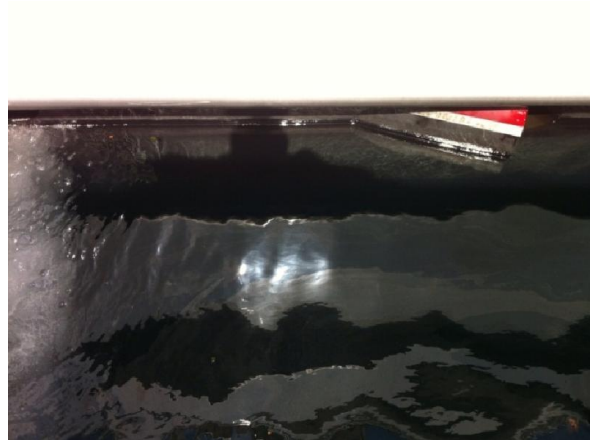
MIA ELISE, 18 hours later with **clean-exhaust** turned **off** – wiped an X with a rag

Observed: Streaks on hull, very dirty, oil and particulate floating on water next to exhaust with **clean-exhaust** **off**

Conclusion: **clean-exhaust** close to 100% effective in eliminating particulate on the hull and in the water

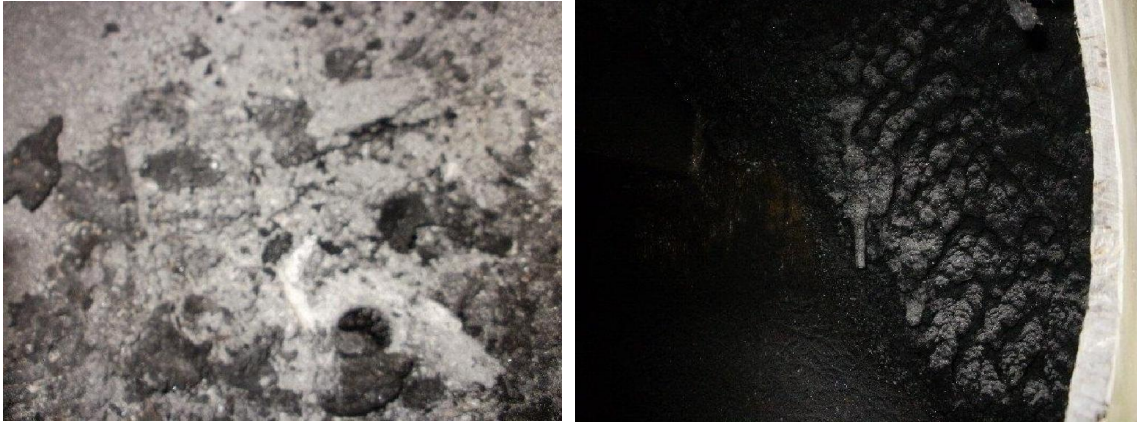
"Large amount of charcoal build-up found in the muffler using *ecoBrew*" The initial, **but proven to be inaccurate**, conclusion was that it was the fault of **clean-exhaust**. Engineer's reaction was to remove the system from the vessel.

Chunk of gunk in the muffler

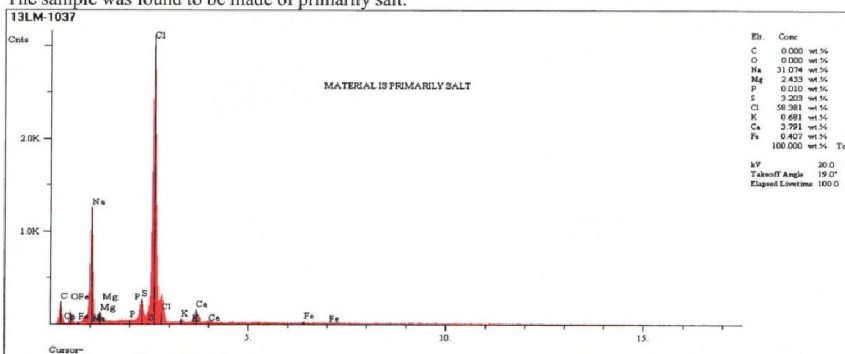
Semi-quantitative EDS analysis was run on the sample submitted to determine the elemental composition. The sample was found to be made of primarily salt.
