clean-exhaust

Two Year Summary

May 2012-March 2014

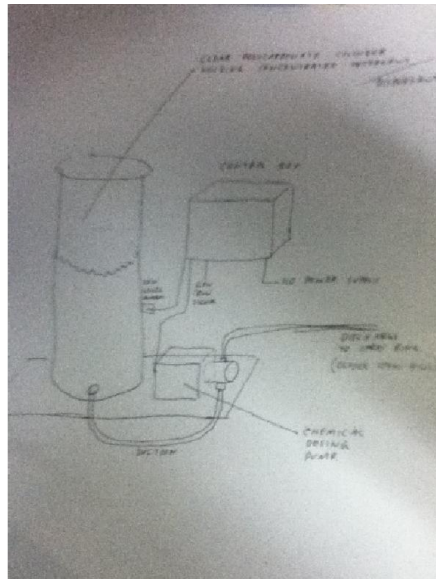
Inventor's first drawing

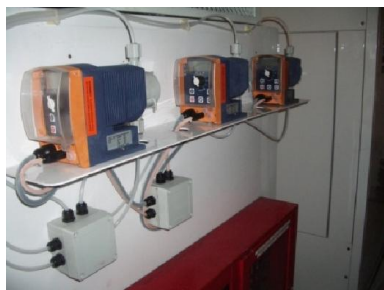
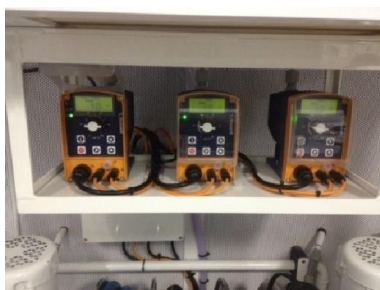
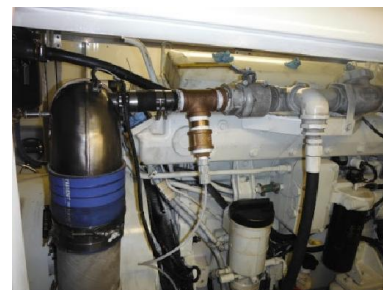
Below is a typical three system dosing pump installation for three generators on the back of the generator box. A dipstick in the 5 gallon container reads out the *ecoBrew* level and sends a warning signal if the *ecoBrew* is low.
